Converting BLI USRA Mikados to CNJ M3s & M3as Mikados

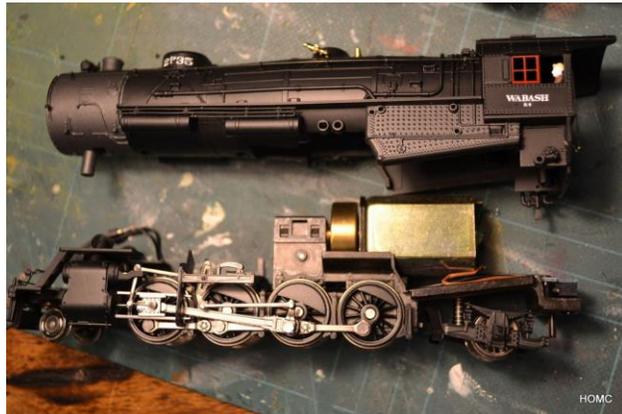
The price of a brass (OMI) CNJ Mikado is frequently in the \$800 - \$1200 range – even when they can be found - and this would seem to justify the work involved in modifying a BLI USRA Mikado (picture to right) which can be picked up on auction sites for \$120 to \$200 even with DCC and a sound chip. Some detailing parts are also required as shown, but this still only takes the price up to about \$300-350.

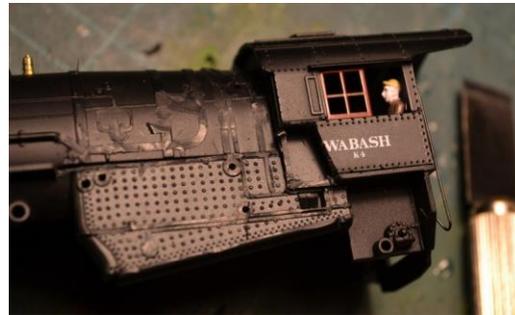
Firstly, all the snap-on removable parts were taken off, then the running board above the firebox was removed with pliers and a flat-ended hobby knife. Other details were also flattened and a careful cut was made into the cab.

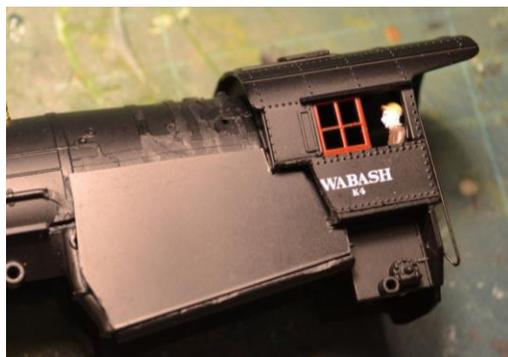
A similar treatment was given to the rest of the boiler, removing surface detail that was not wanted. This is a matter of taste – some details can be retained, but this makes it hard to get an even finish for adjacent parts – or the boiler can be left largely featureless with everything: pipework, boiler bands etc.. needing to be added fresh. In both cases, it is necessary to file after cutting, and then fill with green/white putty and finally sand with sanding sticks (purchased or home-made).

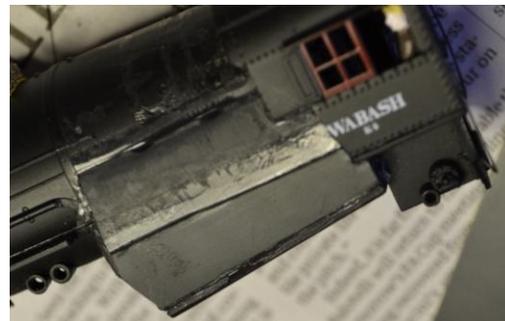
Meanwhile, back to the firebox, a sheet of black plastic-card was cut to the desired shape and glued to the firebox side with polystyrene cement – to fill some of the gaps underneath.

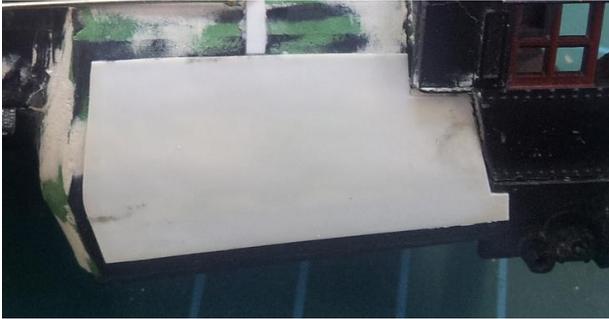
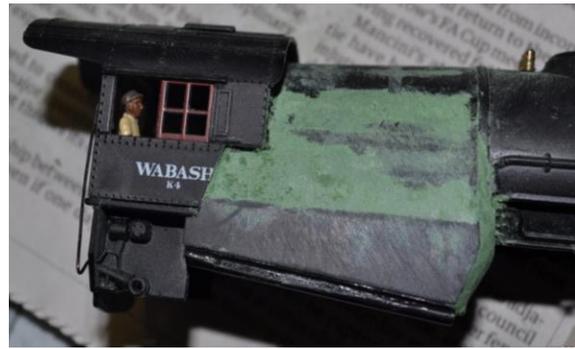
Layers of plastic-card were then added to build up the Wooton firebox shape as shown right. This required

splitting the shapes into two – a largely flat, bottom half and a chamfered top half. The top half was filed to give a rough approximation to a smooth curve.

Green putty and White putty were then used to fill the gaps and give a smooth surface and this was finished with a thin sheet of plastic-card

glued over the top. For this use superglue and ensure that there are no air-gaps. Other details such as boiler bands may also be added in plastic-card but use a MEK solvent for this.

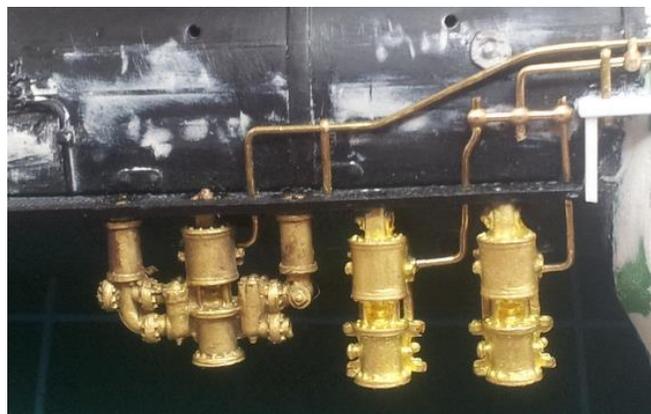
Pumps, Pipes and 'Valves' (M3as shown)

Holes were drilled in the existing running board with a powered mini-drill to take the pumps and they were attached with superglue (as were their mounts in the case of the air pumps).

Most holes are drilled, however, by hand with a pin vise and the appropriately sized drill bit. The picture also shows split pins being used to hold wire and – above the RH air pump - a three hole brass handrail stanchion, with the end cut off, used to represent a set of valves and joints. The wire is bent and placed and rebent and replaced until it finally fits through holes and to the desired position. It is finally held with superglue applied to the minimum number of places. Superglue is applied with cocktail sticks to ensure that only just enough is used.

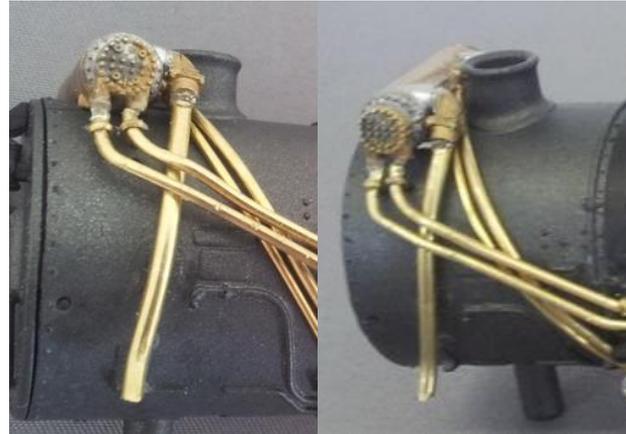
Elesco Feedwater Heater, Check Valve and Cooling Coils (M3as shown)

The rear pipework connections were cut off the body of the Feedwater heater and repositioned (rotated) as shown. These were then soldered on as were the ends. Note that this requires a really hot soldering iron.

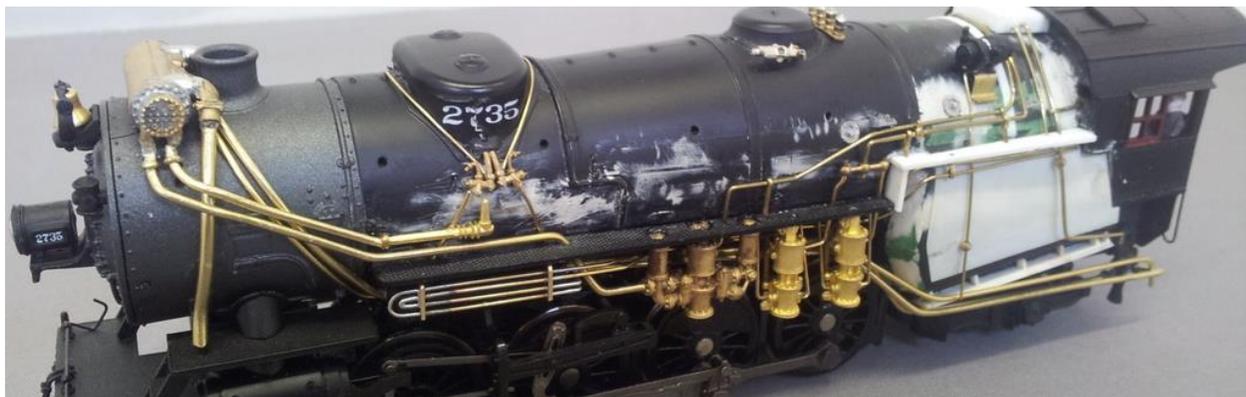
The rather thick brass wire was carefully bent as required, positioned with eyebolts, and superglued in position. This needs to be taken to the full lengths as required and connected at both ends.

This larger picture of the finished LH side also shows the Cal-scale boiler check valve – the join to a piece of brass wire of the same diameter is hidden by an eyebolt and glued; Another eyebolt holds the end in position. The sander valves above it have been cut about and attached to the sand dome. Please also note the remaining white putty on the boiler after filling and sanding.

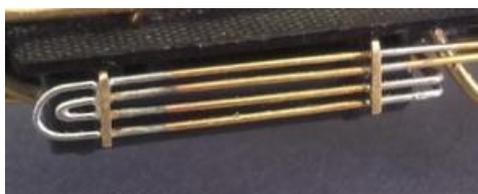
The cooling coils were scratch built from brass bar and wire and soldered together; a very rough jig was used for this. The brass bar extends up and is bent back and glued under the running board. In the picture above it can be seen that the wire is then extended to connect with the water pumps.

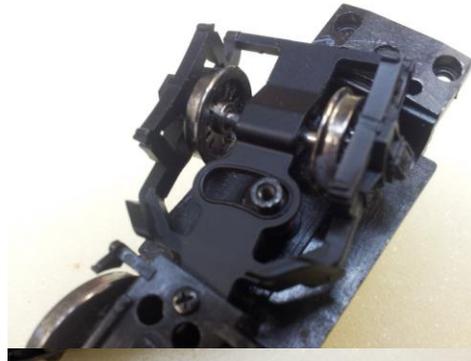
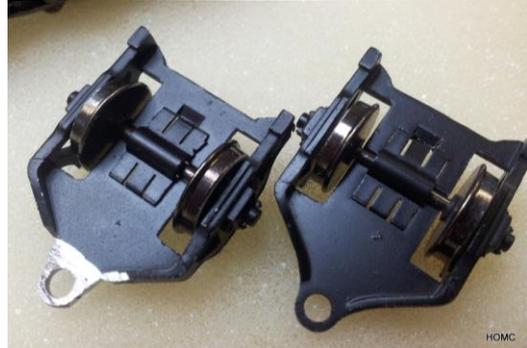
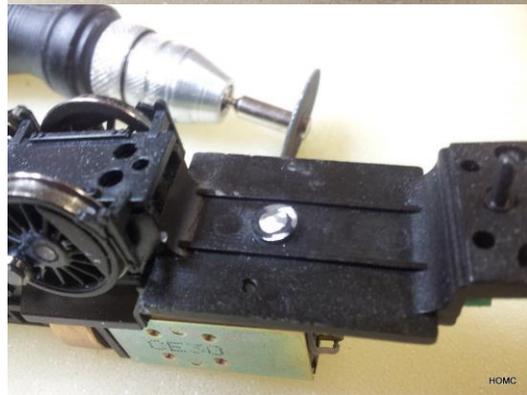
Trailing Trucks

The prototypes had delta trailing trucks – with spoked wheels earlier and, possibly, smooth wheels after the war (WWII). Bachmann delta trailing trucks (with smooth wheels) were used – these are about the right size but are too short. To fit one onto the USRA frame, the hole was drilled out with a rotary narrow file cone on a mini-drill, and the sides were taken back a little as well (R-centre).

After the original truck was removed, the mounting rod was removed with a mini-drill as shown (R-below) and the new truck was fitted to the same mount. The picture below shows how this is really too short. No attempt was made to solve this on this occasion.

1. The Wooten firebox is a little short
2. There are only two cab roof lights – should have been three
3. The cab back is open – it should have been closed
4. The delta trailing truck is too short
5. The trucks on the Bachmann USRA long tender (used on the M3s) are the wrong type
6. The ladder on the Bachman USRA long tender is on the wrong side.

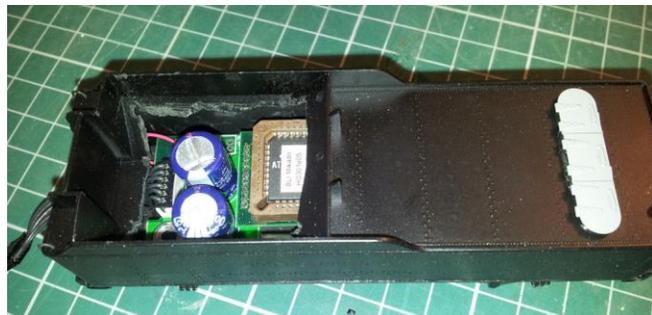
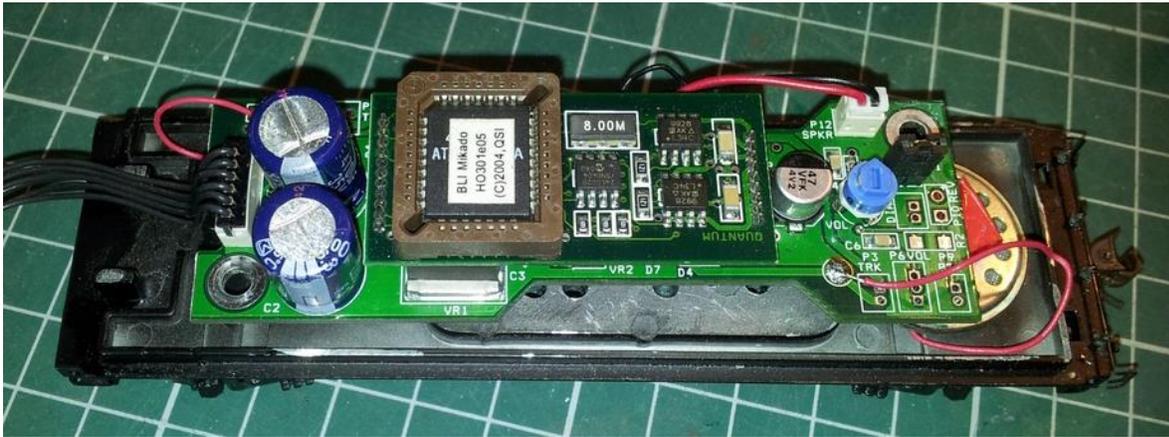
Tenders

Each tender will have its own problems. A large brass tender obtained off an auction site and a Bachman USRA Long tender were adapted for these two models. In both cases the electrical pickups need to be worked out and connected to the BLI Sound chip boards, and holes need to be drilled in the base to let the sound out! Take care of the potential for shorting – the boards can short to the speakers if in contact and the tender to loco connector is best replaced with a plastic version (scratchbuilt).

The insides of these two tenders with the sound chips in position are shown over the page. In the case of the Bachmann tender, the base of the coal bunker had to be removed to make way for the sound chip components. The hole was effectively covered by the plastic coal load. The fit was still extremely tight and the sound as a result was a little muffled.

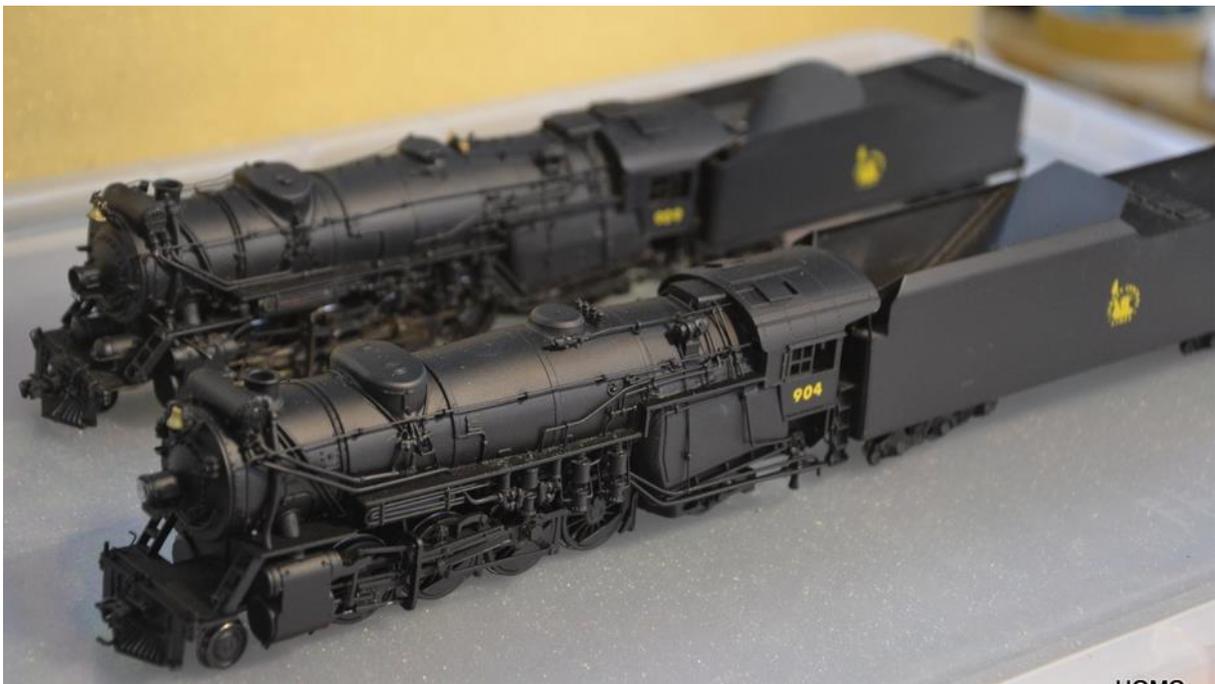
The Result

This photo shows the converted M3as in front of an OMI brass model of the same locomotive. I believe the effect of the much cheaper conversion is very similar. I hope you agree.
